In-situ Acoustic Doppler Velocity Meter Study.

Funding Partners Department of Sustainability & Environment Victoria and Bureau of Meteorology

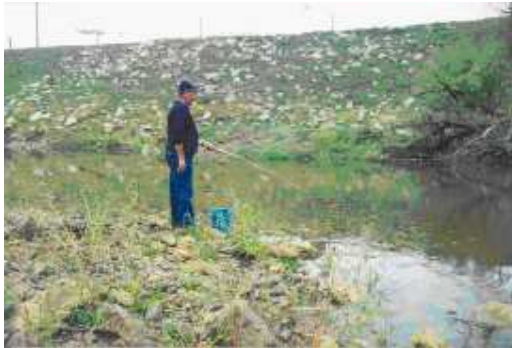
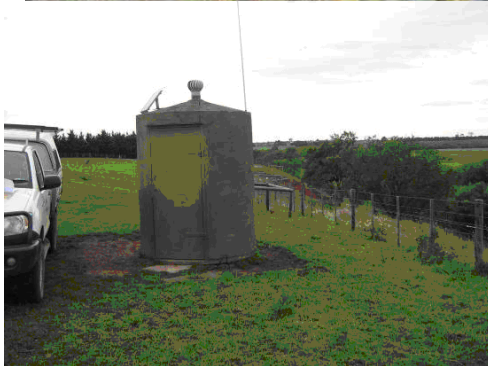
224217 B Mitchell River at Rosehill

This site is located in the broad Mitchell River flats, has a tortuous and unstable primary river channel shown on the left and has a very wide secondary channel shown at right. The Mitchell River terminates at Lake King within the Gippsland Lakes system. The river downstream from the site covers approximately 20 Km with very little fall before discharging to Lake King. It flows along the boundary of the lake for approximately 6 of those Kilometres. The Mitchell River is also unique in that it flows, as a perched stream several kilometres, into Lake King before discharging its flow. Irregular occurrences within the lakes system have the potential to quickly impinge on data accuracy at the Rosehill site

The steep and unstable nature of the primary channel bank required that this site be bored to install the power/communications cabling to the ADVN rather than use open trench techniques.

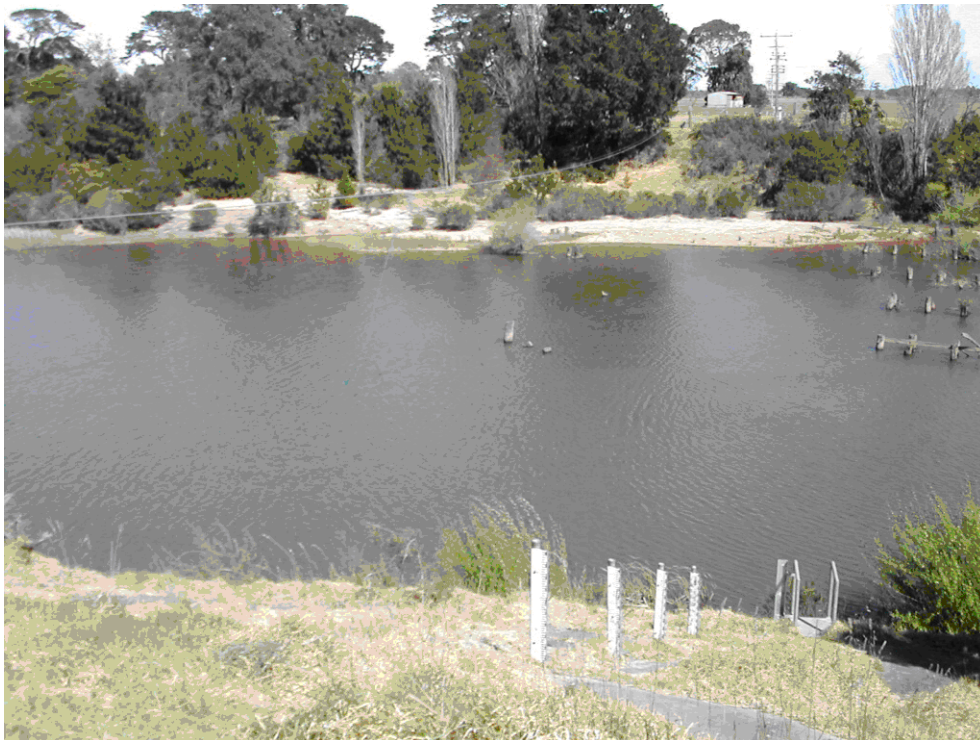
225201A Avon River at Stratford

This site is located on a very broad channel section and is subject to flashy and intense flood events from a relatively small drainage area of 1485 km². The stage-discharge relationship is premised on a potentially unstable natural gravel and sand control. The Avon River discharges to Lake Wellington within the Gippsland Lakes system. The stream channel is heavily vegetated and the vegetation density can vary considerably between flood events.

The width of the channel section presents specific challenges in utilising the suspension monitoring installation at this site especially during extreme events. The effectiveness of the existing suspension monitoring installation can be rated as marginal. The high velocities occurring during major events also preclude the use of other conventional techniques such as boat observations.

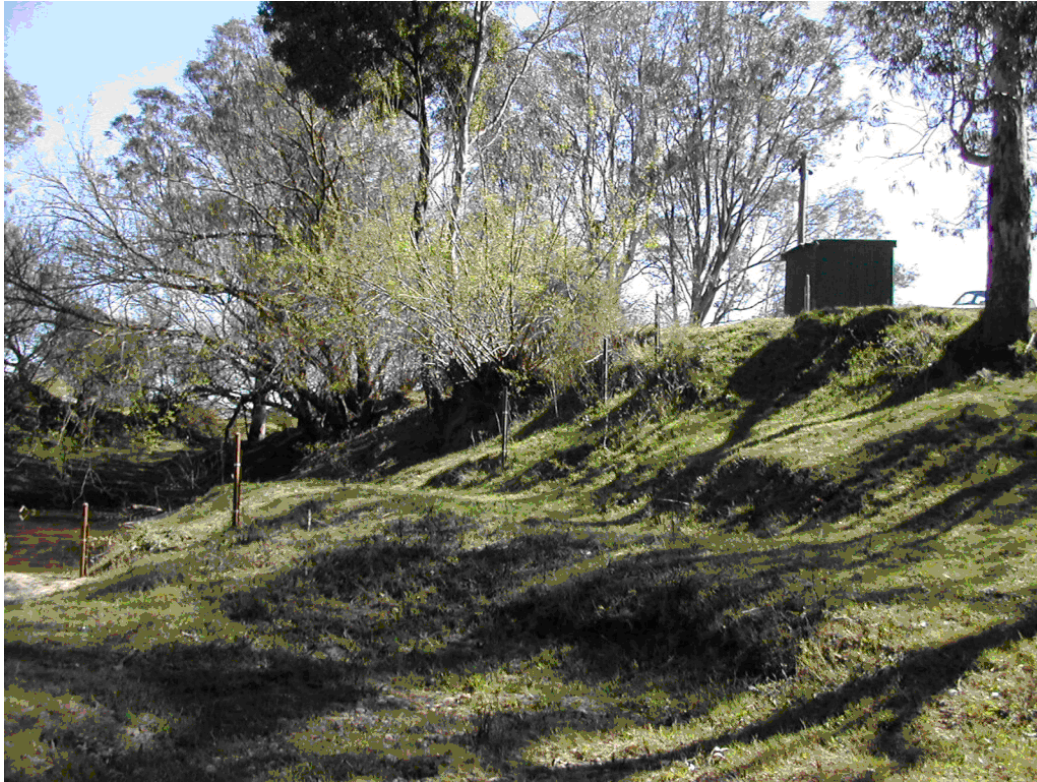
225232A Thomson River at Bundalaguah

This site has been selected for inclusion in the ADVM study as the close proximity of two other monitoring sites (Latrobe River at Kilmany South and Swing Bridge) provides a unique opportunity to undertake some water balance modelling and comparative statistical analysis. It also allows analysis to be made on the back-water effects created through varying flows in each of the streams. The drainage area monitored by the site could be classified as moderate at approximately 3,538 km²

This site is located approximately 5 km upstream from the confluence of the Thomson and Latrobe Rivers within the flood plain section of those rivers. Both streams are significant to the water harvesting activities of various agencies. There are several water storages upstream from the Thomson River site. Controlled releases are often made from those storages. The site is also impacted on by surge actions of Lake Wellington within the Gippsland Lakes system and the subsequent short term variance in back-water that can occur.

Site access for high flow monitoring is extremely challenging and break-outs occur on the right bank at moderately small flows. The tortuous nature of the primary channel also tends to create non-laminar flow patterns.

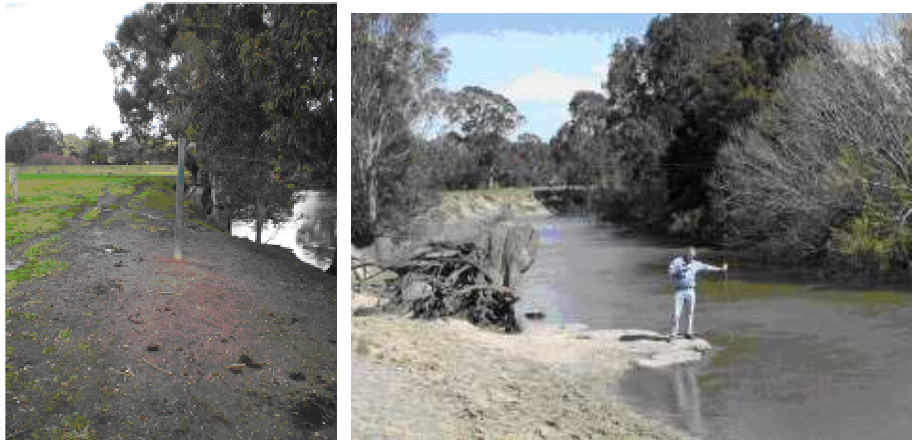
226227A Latrobe River at Kilmany South.

As the accompanying photographs indicate the site quickly becomes inundated in high flow events. It is located approximately 5 km upstream from the confluence of the Thomson and Latrobe Rivers within the flood plain section of the broad Latrobe Valley flood plains.

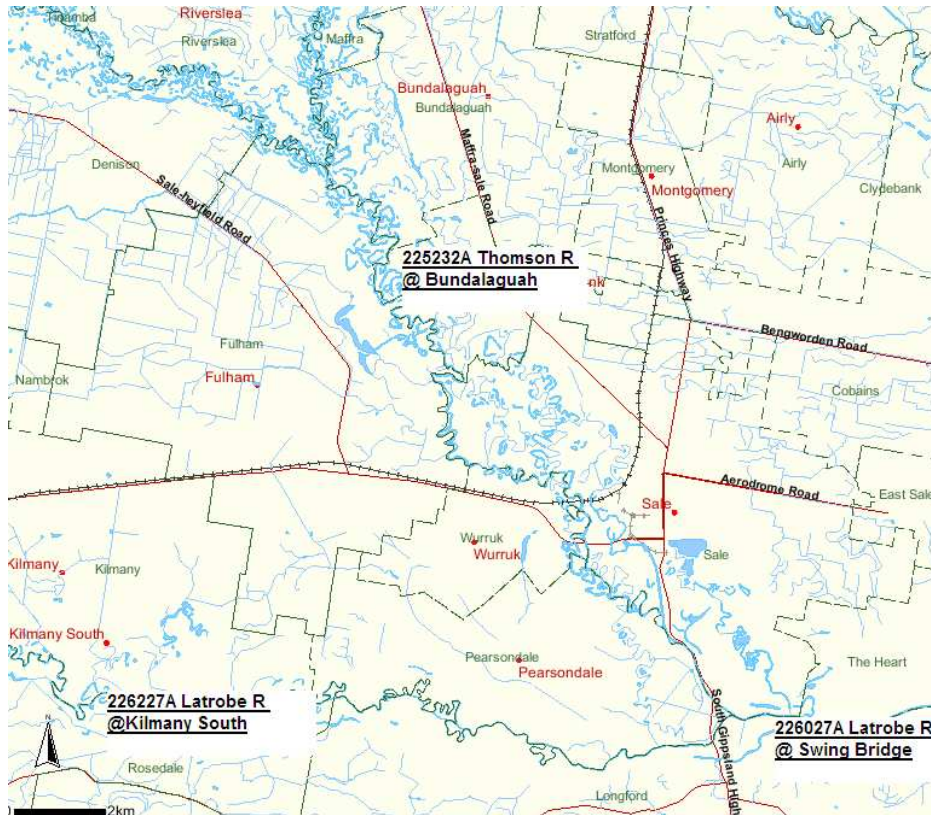
Figure 3. Aerial showing the geographic relationship of Kilmany South, Bundalaguah and Swing Bridge sites

This site is located immediately downstream from the confluence of the Latrobe and Thomson rivers (See figure 2 for layout) within the immediate influence of Lake Wellington in the Gippsland Lakes system and hence is subject to channel seething. Although the site is an identified Bulk Entitlement monitoring point hither-forth conventional flow monitoring technologies have not permitted accurate collection of the necessary data. Hence a “virtual site” was created whereby data from the Latrobe River at Kilmany South and Thomson River at Bundalaguah were summed and assumed to represent the true flow conditions at the Swing Bridge site.

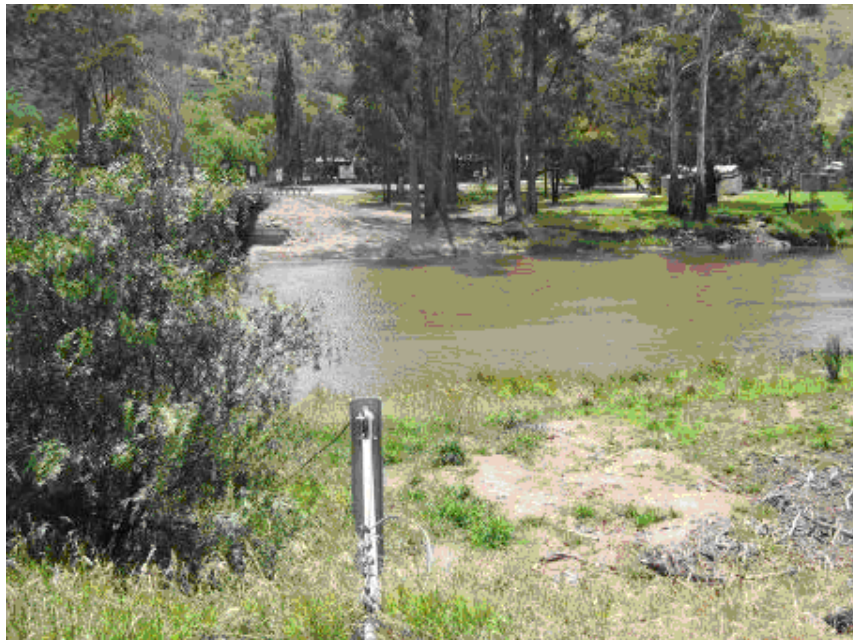
225209A Macalister River at Licola.

This site is approximately 40 km upstream from the storage and provides critical early warning for flows reaching Lake Glenmaggie. It is located within a catchment severely impacted by the 2006 Great Divide South fires. As a consequence the soils of the entire catchment became extremely unstable and subsequent high rainfall events caused mud slides and severe erosion within the catchment and stream channel. In the highest flow event ever recorder (peak of 220,000 ML/D) in July of 2007 evidence suggests that the

stream bed was severely scoured on the rising leg of the hydrograph and then deposition on the falling leg raised the streambed 1 meter above its pre-event level. Soil stability is slowly returning to the catchment but it is anticipated that several more years will elapse before an acceptable level of stability returns.

High flow events in 2007 destroyed the sites suspension monitoring installation and it has been estimated that the reconstruction cost would exceed \$40,000. Hence the ADVN technology offers a cost effective alternative.

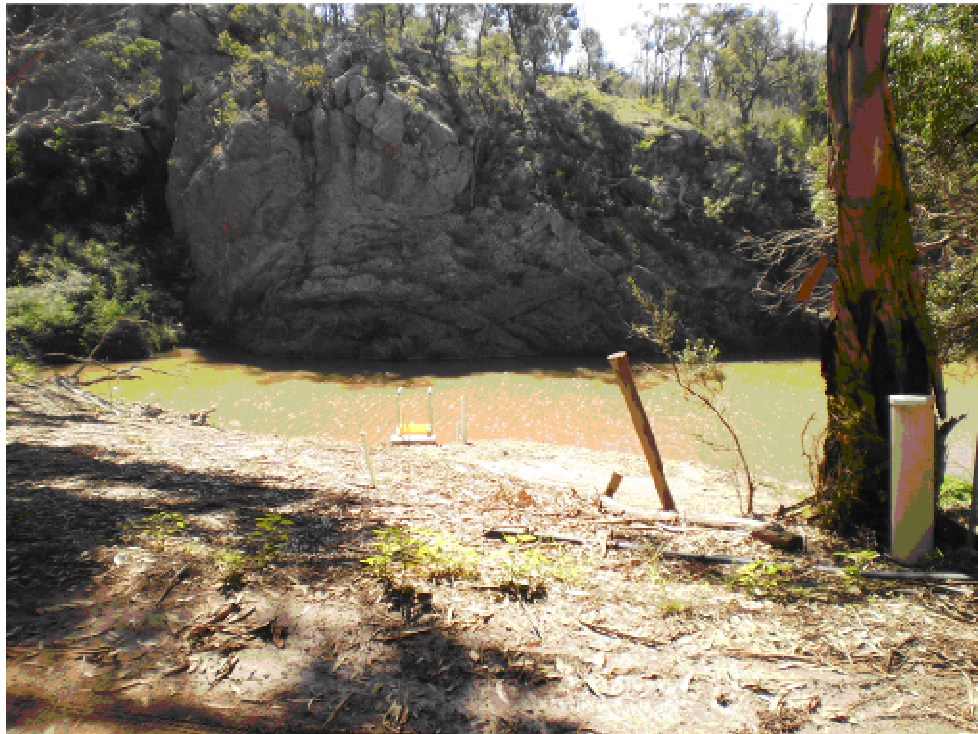
225204A Macalister River Downstream from Lake Glenmaggie.

This site is located 500 meters downstream from a major storage fitted with 14 radial lift gates. The flow at this site is well contained within a stable channel. However data accuracy can be impacted by debris passing through the storage.

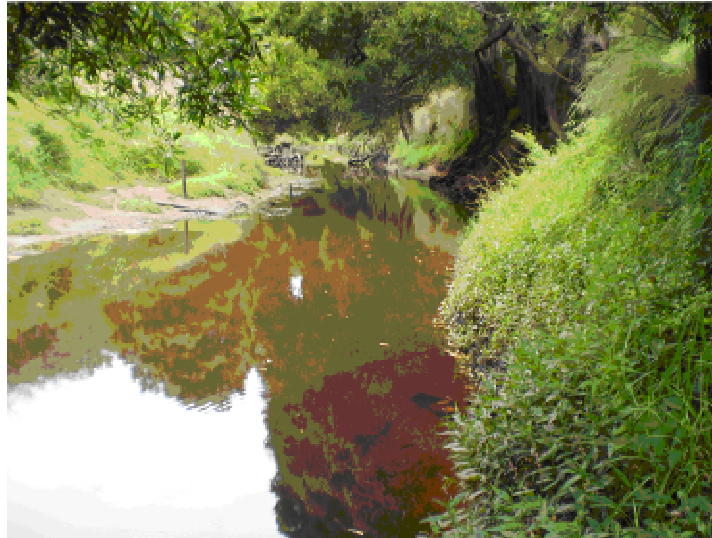
235224A Gellibrand River at Burrupa

This site is located approximately 16 km upstream from the ocean. It is suspected to be impacted by tidal variations and possible salt wedge intrusion. The site was selected for the unique opportunity of studying those impacts and determining how accurately flows could be monitored in such an environment.

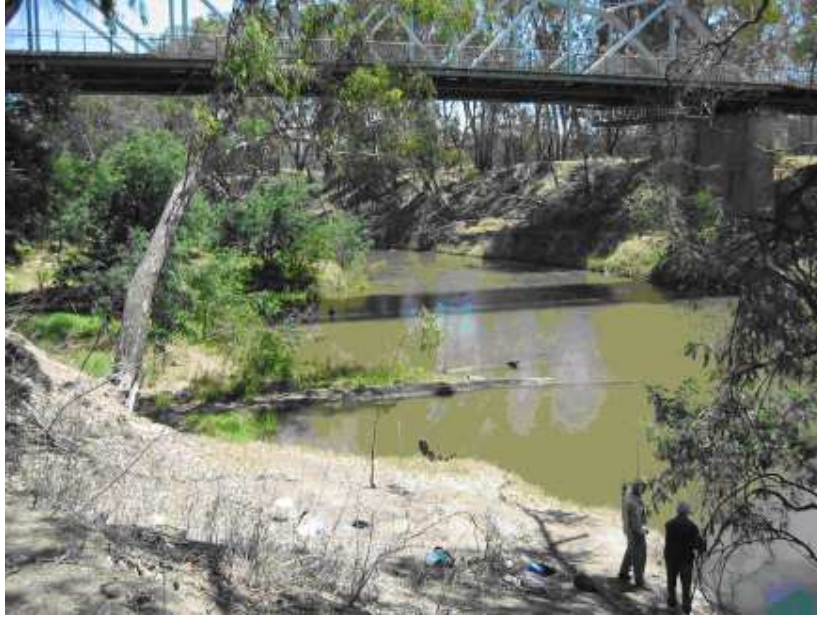
405200A Goulburn River at Murchison

This site is located approximately 185 tortuous river kilometres upstream from the confluence of the Goulburn River with the Murray. However it is known to be impacted by back-water and during major events flow conditions are disrupted by water passing to and pooling in the Barmah Forrest approximately 35 river kilometres downstream from the site.

The flow is contained within a well defined river section and an effective suspension monitoring installation is located at the site. Access is possible to the site in all but the most extreme events.

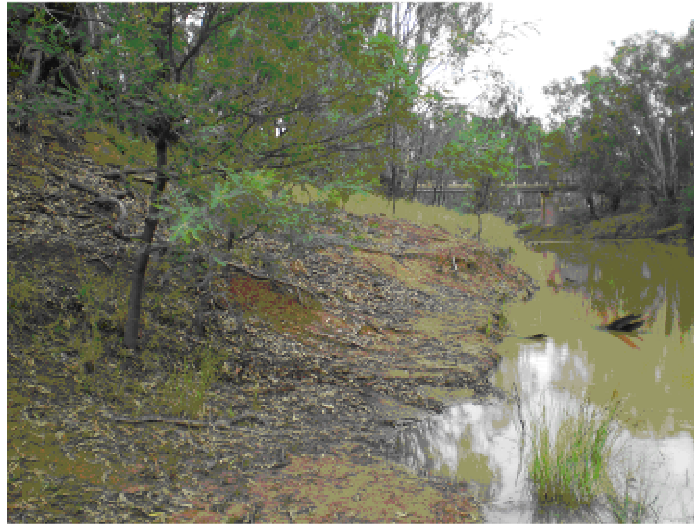
405232C Goulburn River at McCoys Bridge

This site is located approximately 55 tortuous river kilometres upstream from the confluence of the Murray and Goulburn rivers and is heavily impacted by varying back-water effects from the Murray River. Flows at this site are heavily impacted on by multiple peaks in the hydrograph.

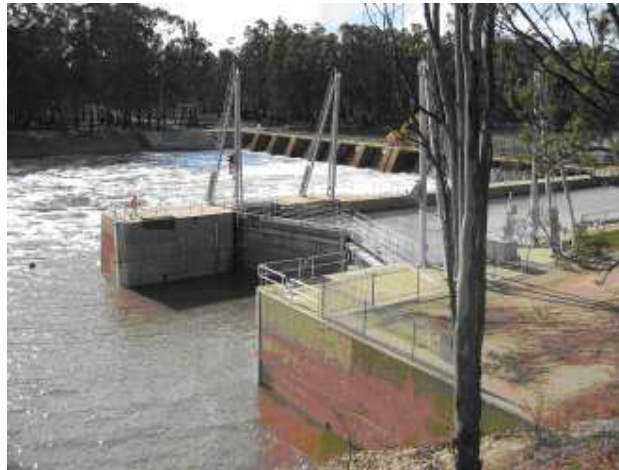
414203C Murray River at Euston

This site is the final monitoring point before the Murray enters South Australia and is critical for determining accurate pass-down river flows. It is located within the loch system of the Murray and consequently is subject to continual, but variable, back-water from the upstream loch. The site is politically sensitive and data derived at the site is under constant scrutiny for accuracy.

The site is located in an extremely hostile environment on the downstream side of Loch 7 in the turbulent tail-water area when flows are released from the loch.
